WVT-TR-76029

ON THE FRACTURE BEHAVIOR OF GUN STEEL

M. H. Kamdar

July 1976

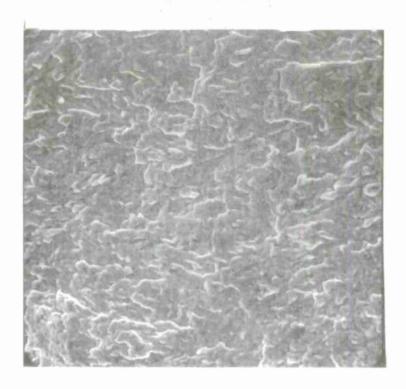
Fig. 11
Figs. 10 & 11. These micrographs show that in regions 2 and 3 on the fracture surface in Fig. 8, are essentially ductile, Mag 960X.

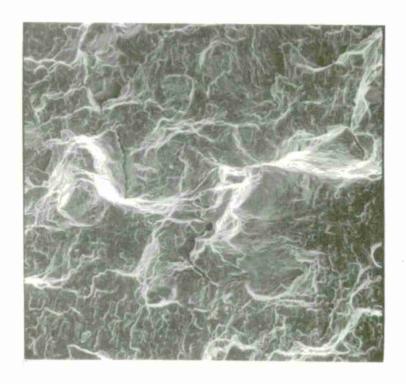
Fig. 13
Figs. 12 & 13. These micrographs show intergranular cracks in region 7 and 8 in Fig. 9.

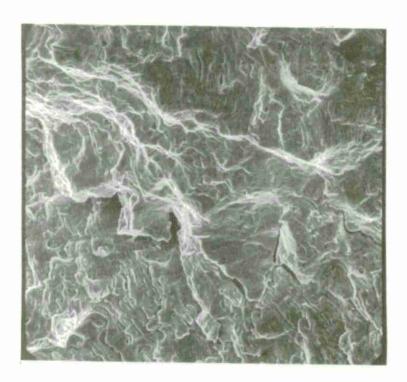
Fig. 17
Figs. 16 & 17. Show the fracture surface in regions 3 and 5 in Fig. 14. Notice that fracture is mixed, i.e. ductile with intergranular cracks mag 960X.

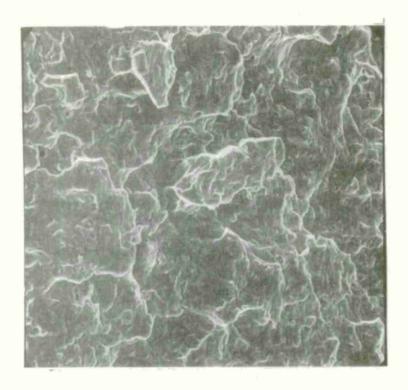
Fig. 20. Shows the fracture surface appearance in region 3 which is similar to that in Fig. 19, 960X.
